**FHWA/IN/JTRP-99/4**

**Final Report**

**EMBANKMENT WIDENING DESIGN GUIDELINES  
AND CONSTRUCTION PROCEDURES**

**September 1999**

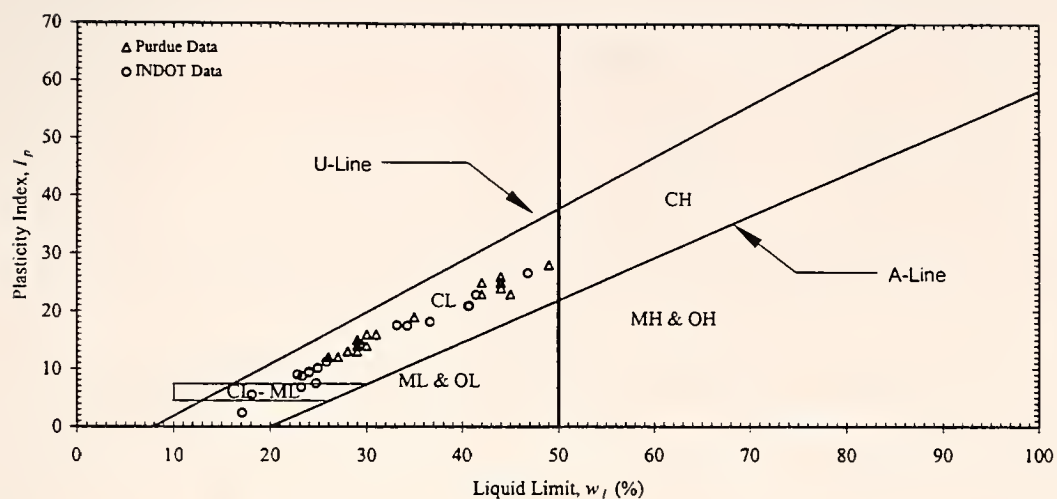
Figure 4.2. Atterberg limits data, I-69, Madison County, Greenfield District.

A post-failure investigation was performed by INDOT. The field work was performed between December 1994 and March 1995. As part of this investigation seven borings were advanced and split-barrel samples were collected. Index tests, including grain size distribution, hydrometer and Atterberg limits analyses were performed on select split-barrel samples. The index test data has been summarized in Figures 4.2 and 4.3. As indicated by the index test data, the soils in the original embankment and those used to steepen the sideslopes are primarily low plasticity, fine grained soils, classified as CL in accordance with the Unified Soil Classification System. The activity, *A*, of these soils is approximately 0.75 on average, indicating that illite is the primary clay mineral.

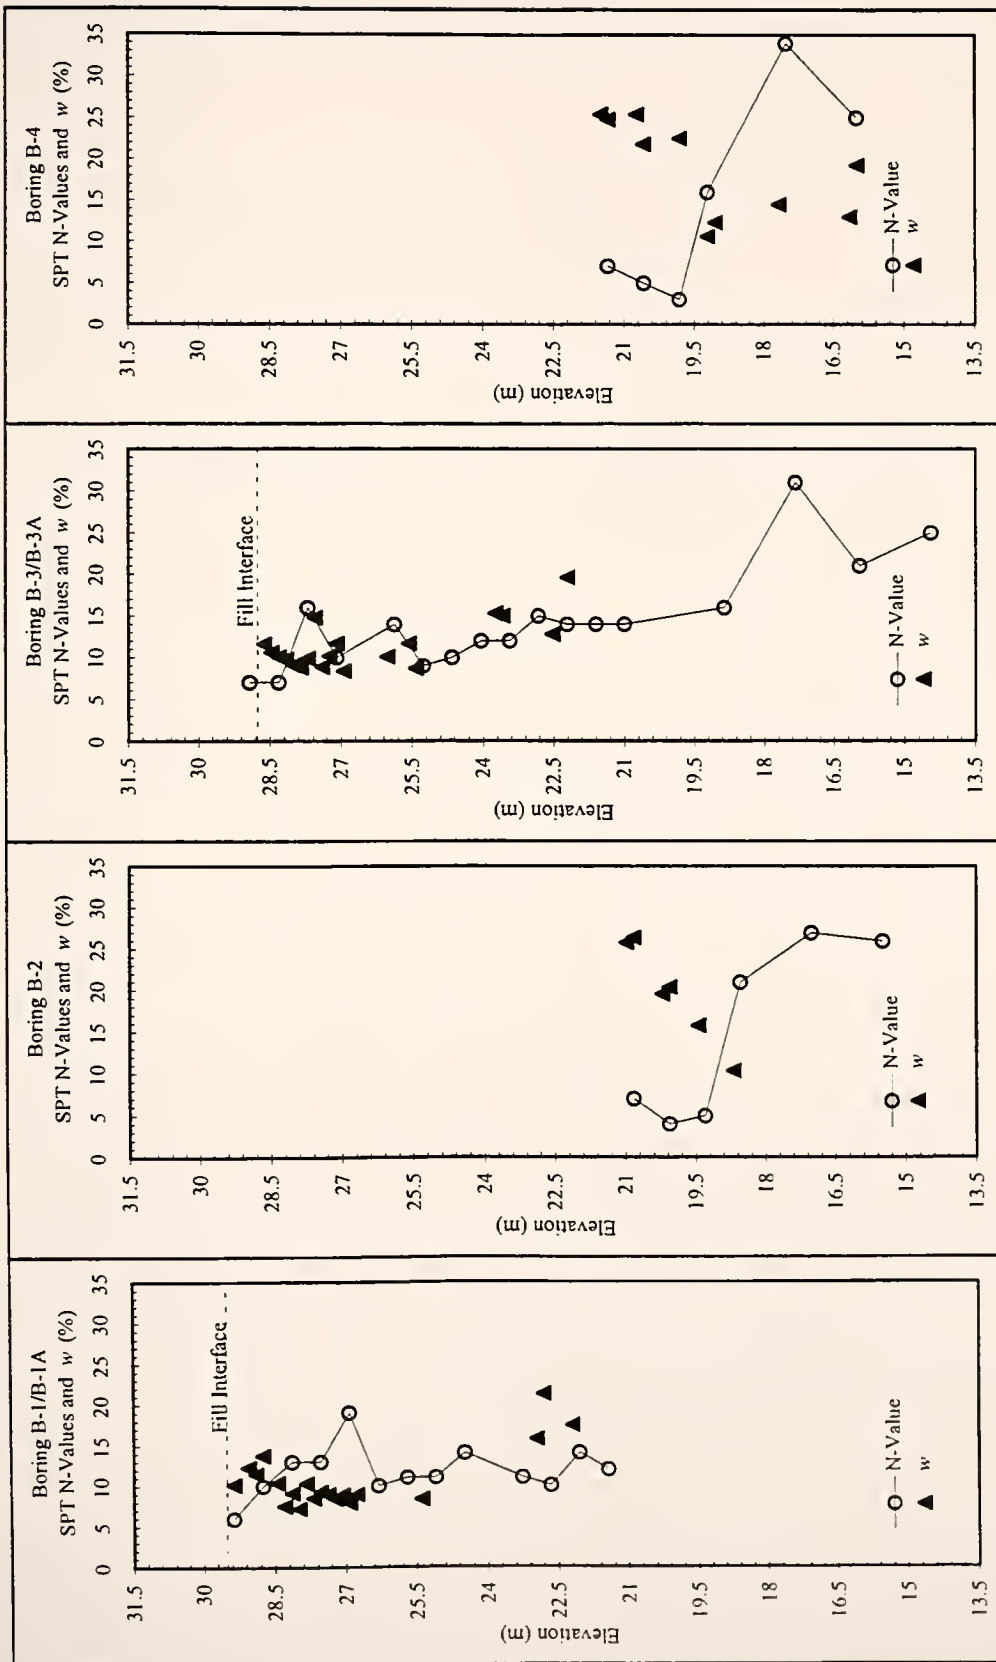
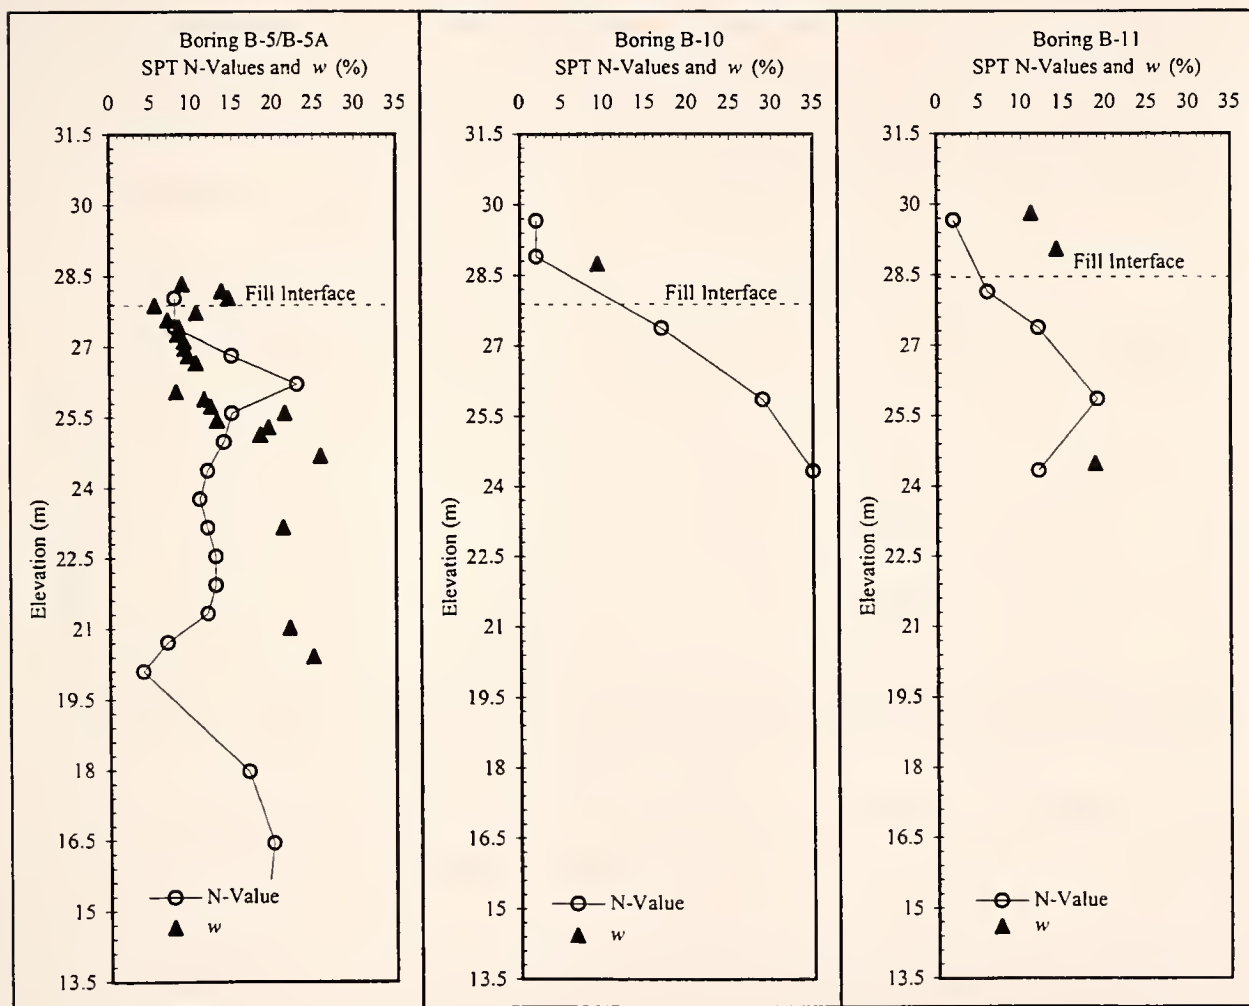
Figure 4.4. Standard penetration test data and water content profiles, I-69, Madison County, Greenfield District.

The SPT data and moisture content profiles for the borings are presented in Figure 4.4. The estimated maximum depth of fill placed to widen the embankment is indicated on the profiles and is based on sideslope geometry. SPT data indicates that fill soils beneath the pavement are generally loose to medium dense (B-1 and B-5) or medium stiff (B-3). On the sideslope (B-10 and B-11), surficial soils are very loose or very soft; the consistency or density of these soils has likely been altered by the slide, and by surface water infiltration. With increasing depth, the embankment soils becomes stiff.

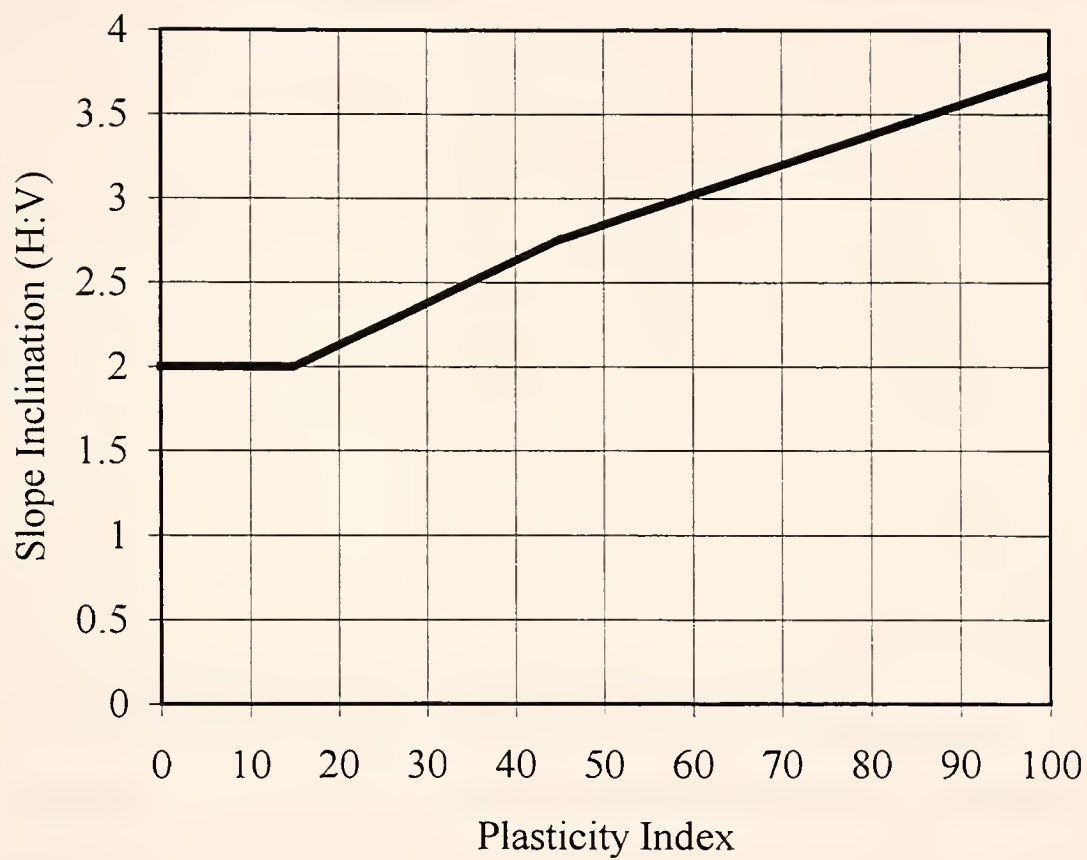
Figure 5.2 Recommended slope inclination as a function of plasticity

A general rule of thumb of 2H:1V is often used to define the limiting safe slope inclination for compacted soils. This inclination was consistent among the survey respondents from other state departments of transportation throughout the US as outlined in Chapter 3. However, there are soil types that are used occasionally in embankment construction for which this inclination may be too steep. In general, the effective stress friction angle of a soil decreases with increasing plasticity (Mitchell, 1974). Accordingly, soils possessing higher plasticity should be constructed at flatter slopes to provide adequate margins of safety.

Sloughing is attributed to poor compaction and/or saturation of the slope. Better management of surface water run-off will reduce surficial erosion and sloughing; thereby, reducing slope maintenance costs. Where slopes are steeper than recommended in Figure 5.2, or Table 5.1, site specific analysis is needed to consider overall stability and sloughing stability of the slope.

The data from Mitchell (1974) were used to develop a simple relationship between plasticity index and slope inclination that is recommended for soils otherwise compacted according to the INDOT *Standard Specifications*. The relationship is provided in both graphical (Figure 5.2) and tabular (Table 5.1) formats. These recommendations were developed assuming prompt development of vegetative cover and controlled transmission of surface water runoff. Moreover, the slope inclinations

5. Modify the INDOT *Standard Specifications* to include the recommendations made in Figure 5.2 and Table 5.1 to limit the maximum slope inclination depending on the plasticity of the fill soils. Site specific testing and stability analysis should be performed if use of steeper slopes is desired.
